210 Ft Advanced Antenna System
Report on Hydrostatic Bearing Damage

8 November 1965

HYDROSTATIC BEARING
RUNNER DAMAGE LAYOUT

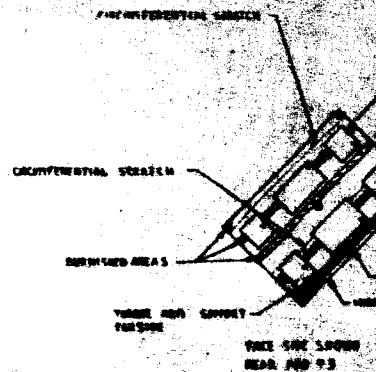
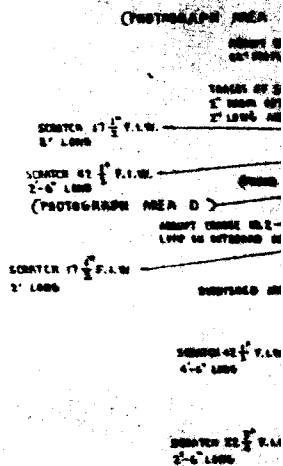
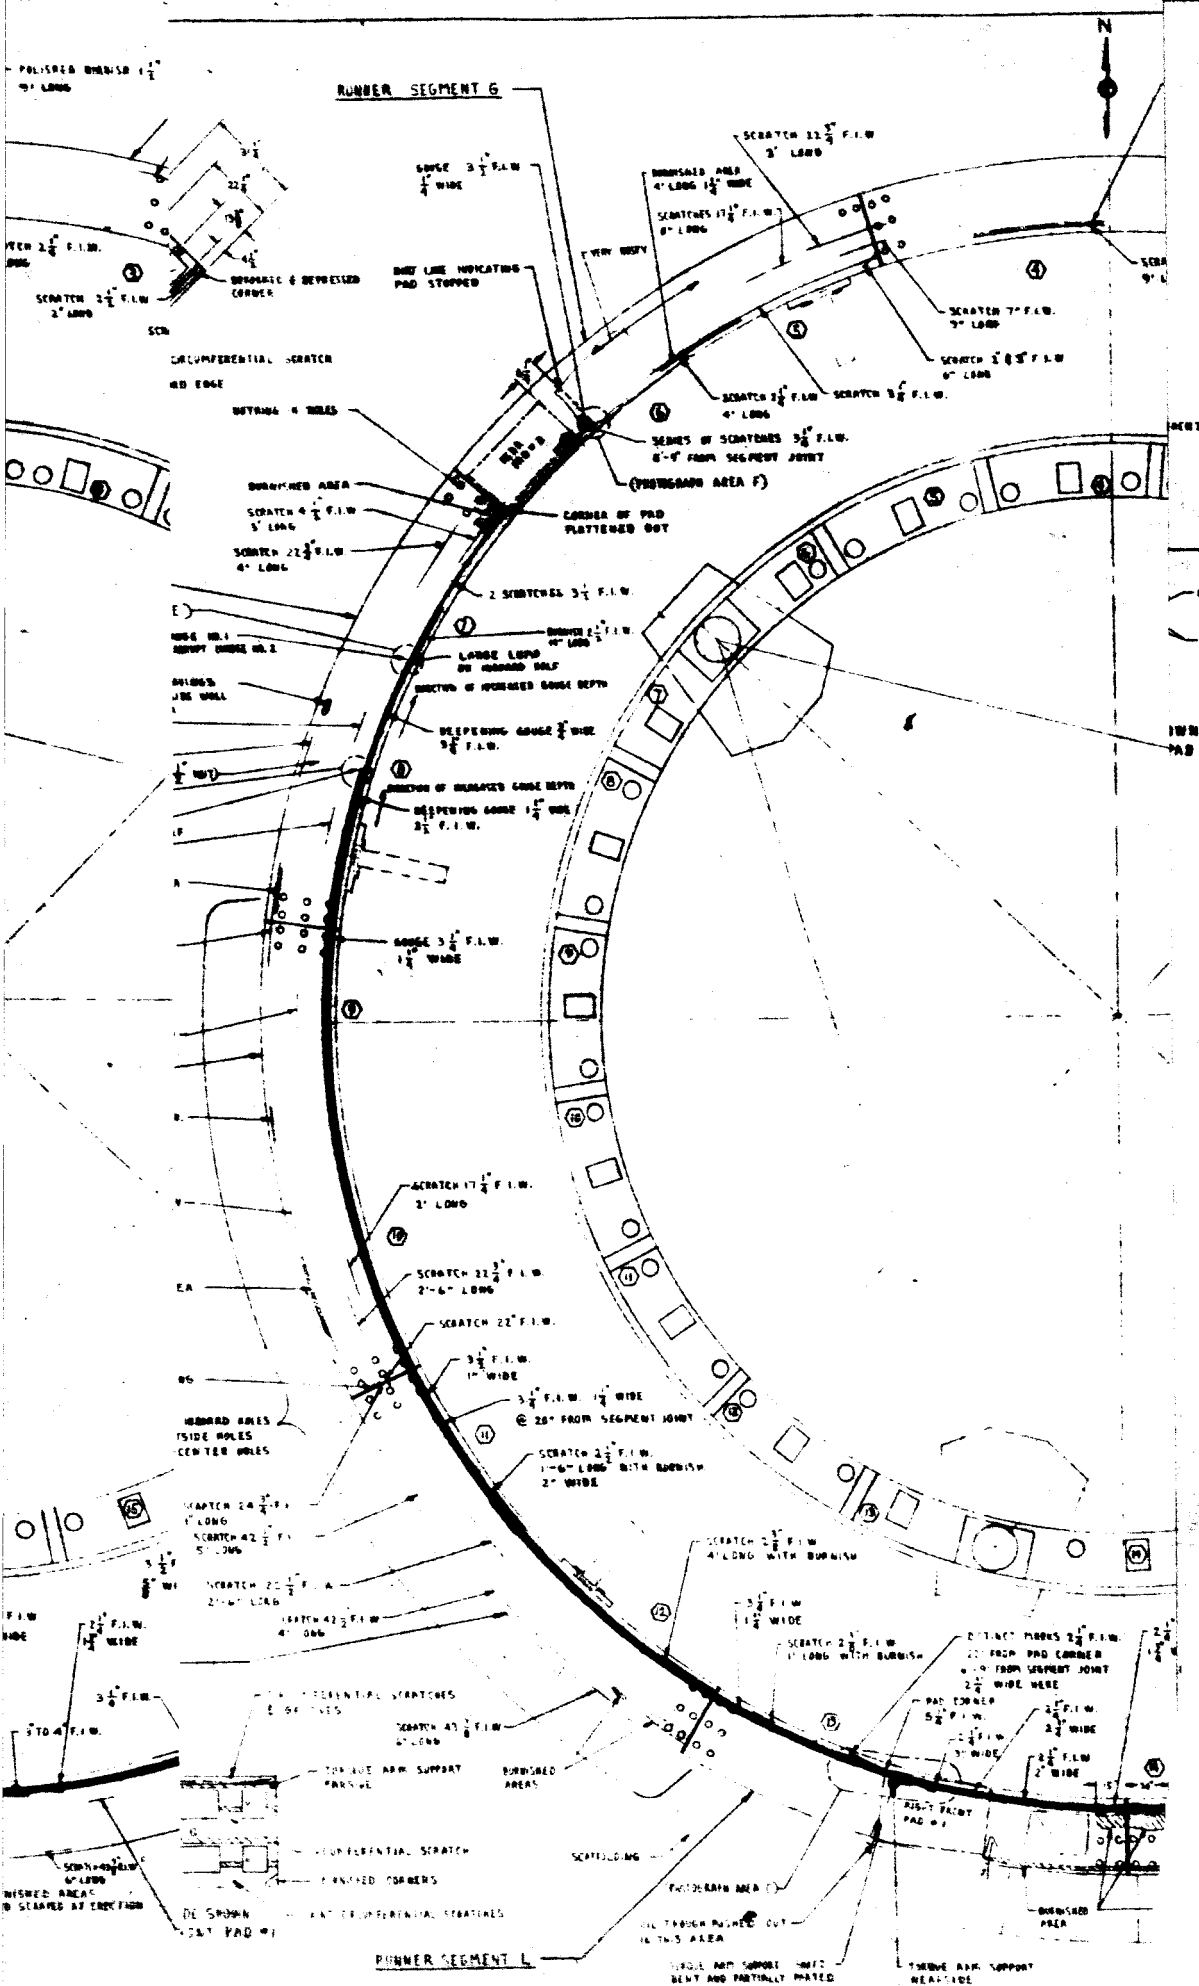
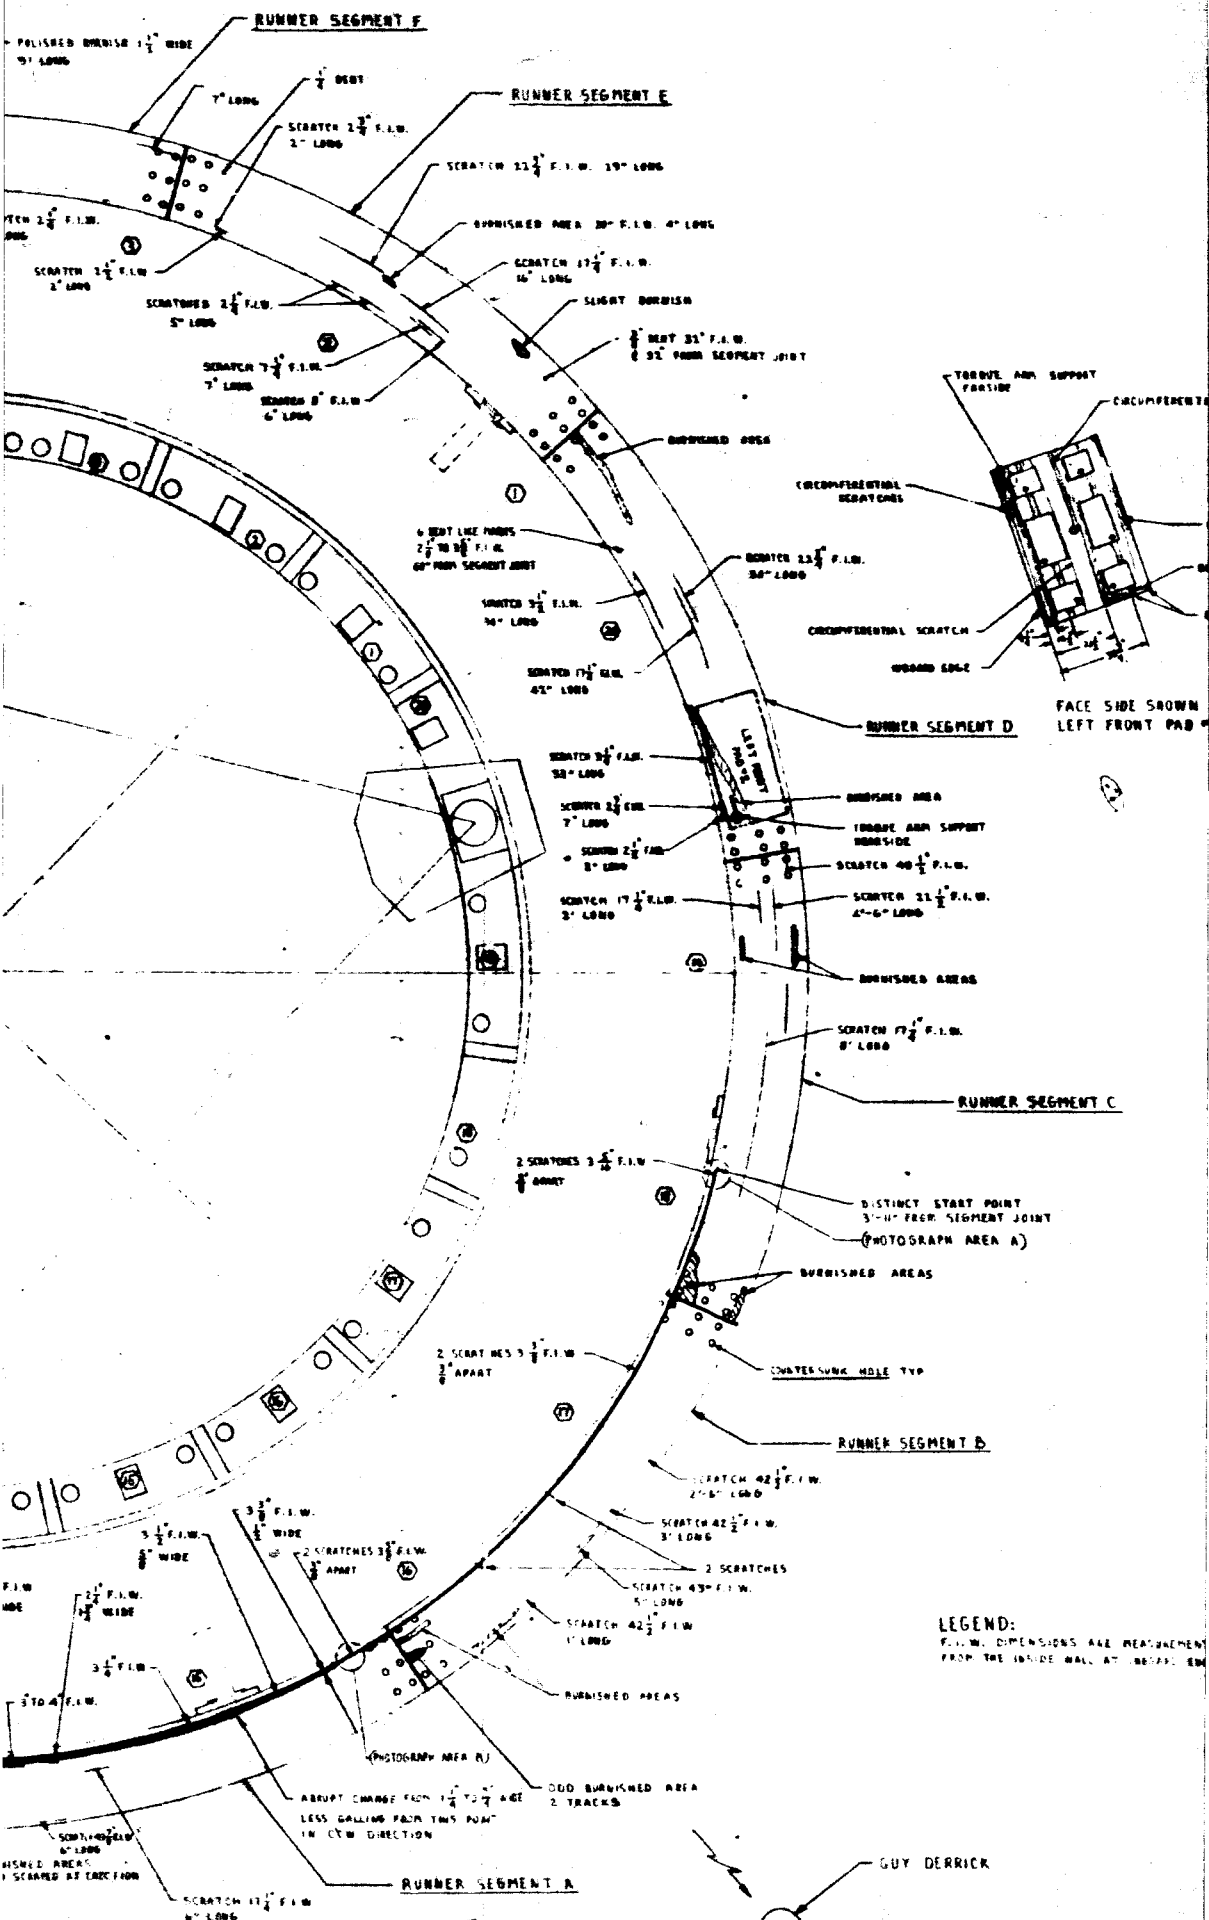
Figure 1

On 2 September 1965 an accident causing damage to the azimuth hydrostatic thrust bearing occurred during a routine azimuth rotation of the antenna by the contractor to test the cable wrap-up. Immediate inspection showed that the right front pad of the bearing had grounded and that the resulting force had broken the antirotation link support on the pad, permitting the pad to rotate and push out the reservoir walls (see photograph, Figure 4). Further investigation revealed severe gall marks about 3 inches from the inside wall and covering about 180 deg of the runner (Figures 6 through 12), on the right inside corner of the rear pad and along the full length of the inner sill of the right front pad (Figures 13 through 16). There were also minor scratches and burnish marks on the bottom of each pad and at various places on the runner surface. These are shown on the runner damage layout, Figure 1, and in the attached photographs.

- On 12 August the antenna was moved from position one to position two (Figure 1). No pad or runner marks are directly traceable to this motion.
- On 23 August a contractor technician fitted each high pressure filter with a differential pressure gauge and left the high pressure skids with the

- On 24 August the antenna was move in azimuth clockwise from position two (Figure 1) through position three to position four in connection with the hyperbola installation and other construction operations. The evidence indicates that during this motion the right inner corner of the rear pad was dragging, cutting scratches about 1/16 in. wide and about .015 in. deep in the runner approximately 3 1/2 in. from the inner wall (Figure 11). The dragging force of the pad was accentuated by the action of the pad anti-rotation link, which tends, for this configuration of drag and direction of motion, to force the dragging corner into the runner while keeping the pad from rotating. (See Figure 2.)

- On 24 and 25 August in connection with placing the feed cone, the antenna was rotated counter clockwise from position four through position five to position six (Figure 1). During this motion the anti-rotation link, because the motion was in the opposite direction of that going from position two to position four, probably cleared the dragging corner of the rear pad causing little or no damage to the runner.

- On 30 August the antenna was moved clockwise from position six to position seven, and then on 2 September to position eight where the final damage occurred. (See Appendix I for detailed description of events at this time). During this motion the rear pad inner right corner apparently was again dragging, causing small scratches as previously described until it reached the 5 o'clock position on Figure 1, when the scratching changed to galling (Figures 6, 7, and 8). The galling continued until the pad was in about the 10 o'clock position (Figures 9 and 10). At this point first one lump then a second lump of metal were ejected from behind the pad, apparently relieving the galling so that no further serious damage was done by the rear pad during the balance of the motion to position eight. In the meantime the right pad encountered the crests of the gall marks left by the rear pad in the 5 to 6 o'clock section of the runner. These "cutting and abrading tools" caused severe damage over the entire length of the pad and finally resulted in so much rotational movement that the torque link, which normally restrains such rotation, was broken.

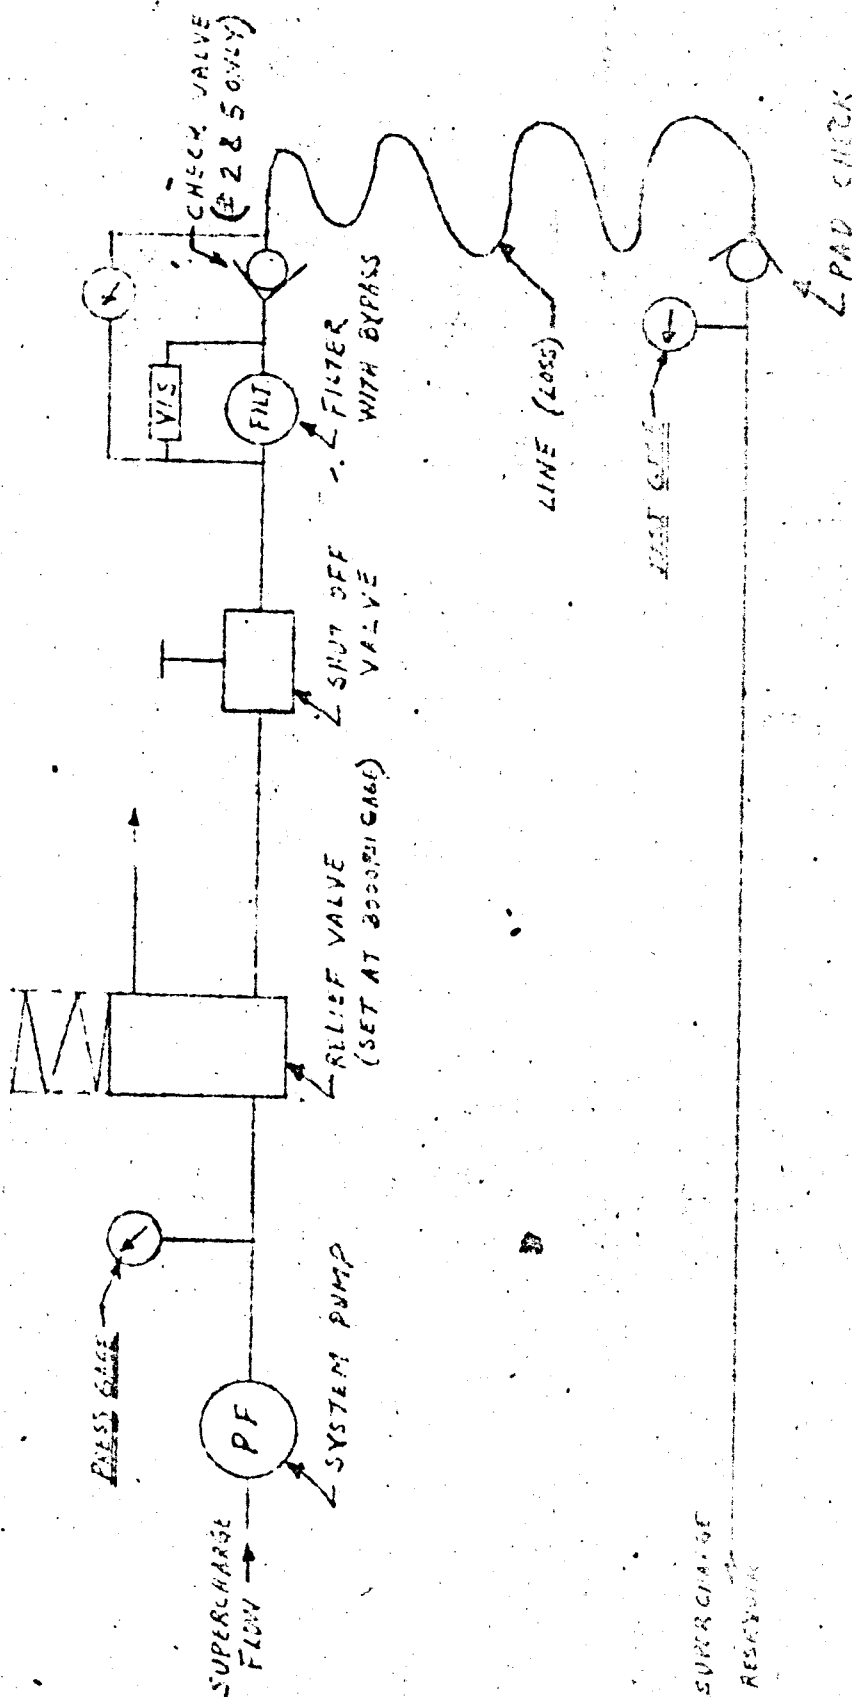
FIGURE 1 SYSTEM LOSS

- b. Two relief valves were tested for resetting with varying relief pressures from 500 psi to 4000 psi, the resetting pressures in all ranges was less than 1%. Reference Figure 3 and 4.
- c. Connecting the complete hydraulic line from the pump to and including the check valve at the pad (see Figure 1) with the shut off valve full open, the pressure drop at the pad was measured at 175 psi.

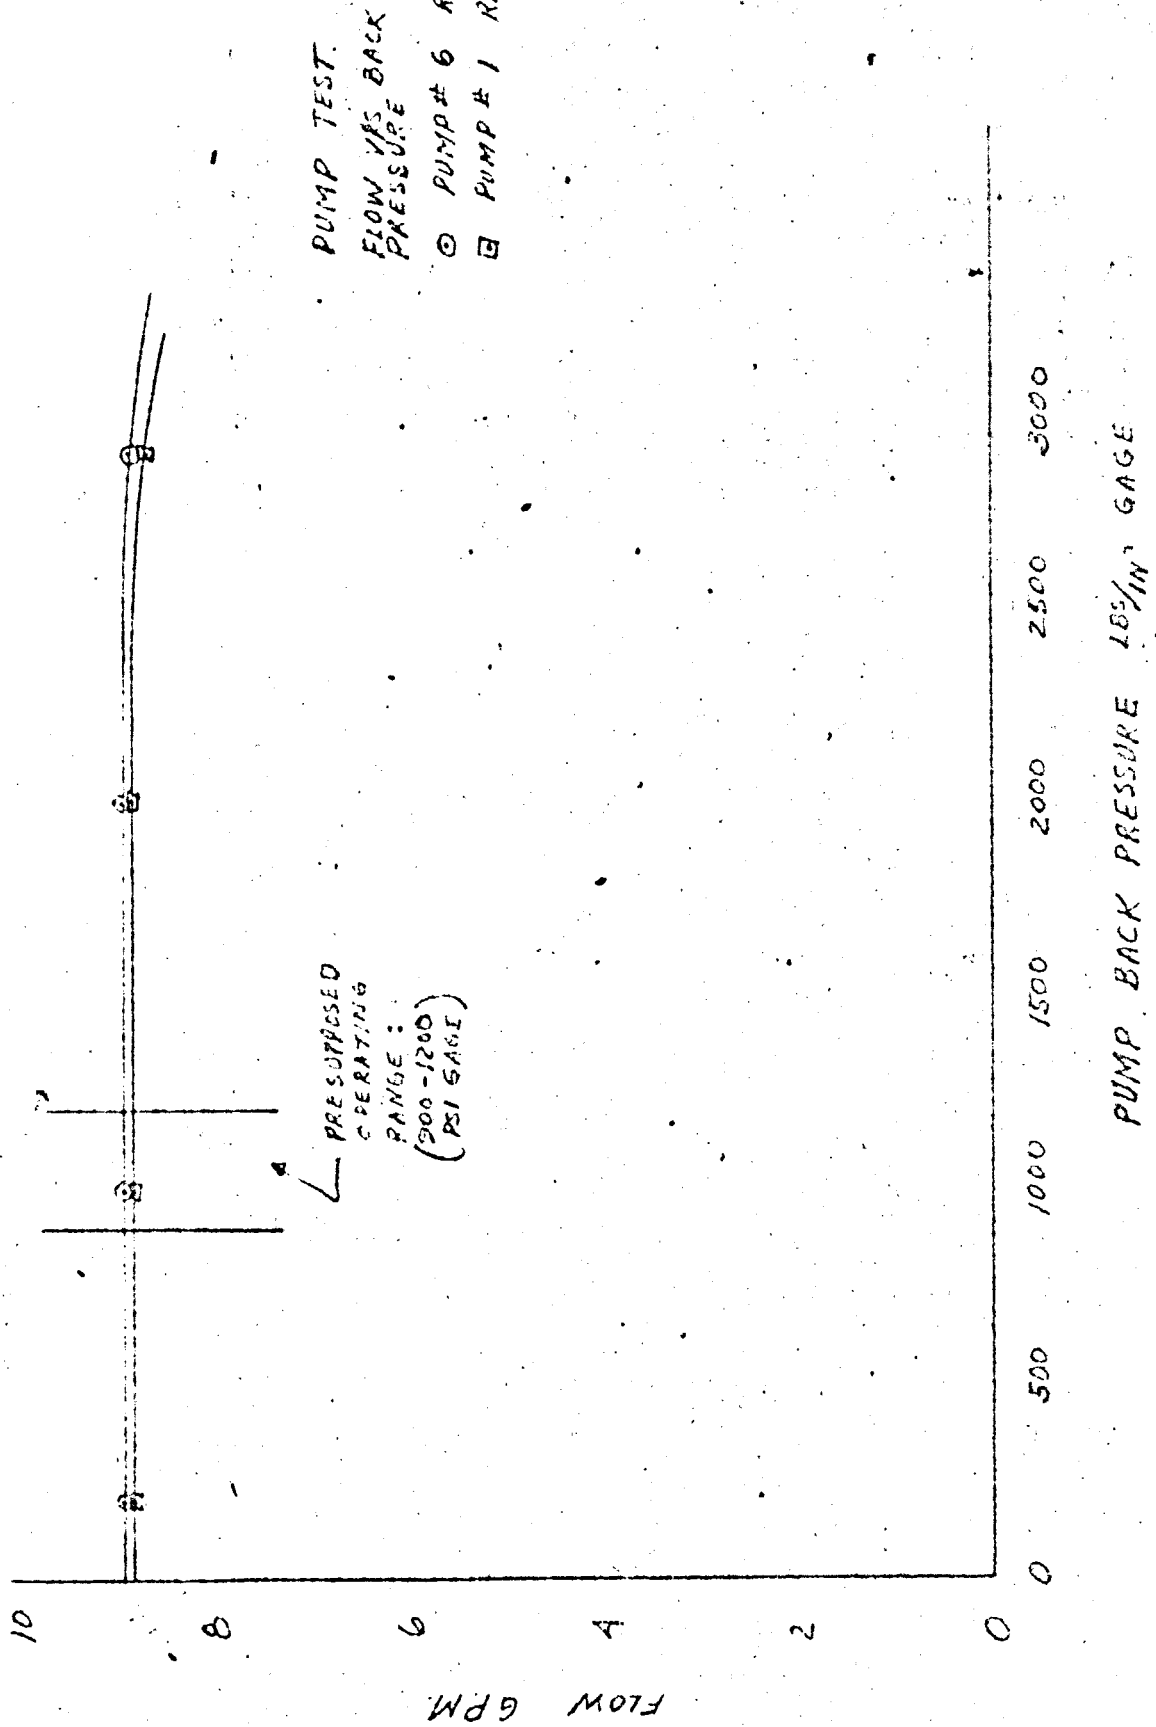
FIGURE 2

1. Relief valves were checked in the as is condition to verify checks made at Rohr.
2. The relief valves were then set to relieve at 3000 psi and checked for reset pressure level. Reference Figure 3.
3. Check the flow rate of the pump with varying relief pressure settings from 200 psi to 3000 psi using a Fisher & Porter Turbine Flowmeter. For results, see Figure 2.
